Sony Ericsson xPeria Active Headphone Jack Replacement

This guide will walk you through the steps to replace a faulty heaphone jack on your Sony Ericsson Xperia Active cellphone.

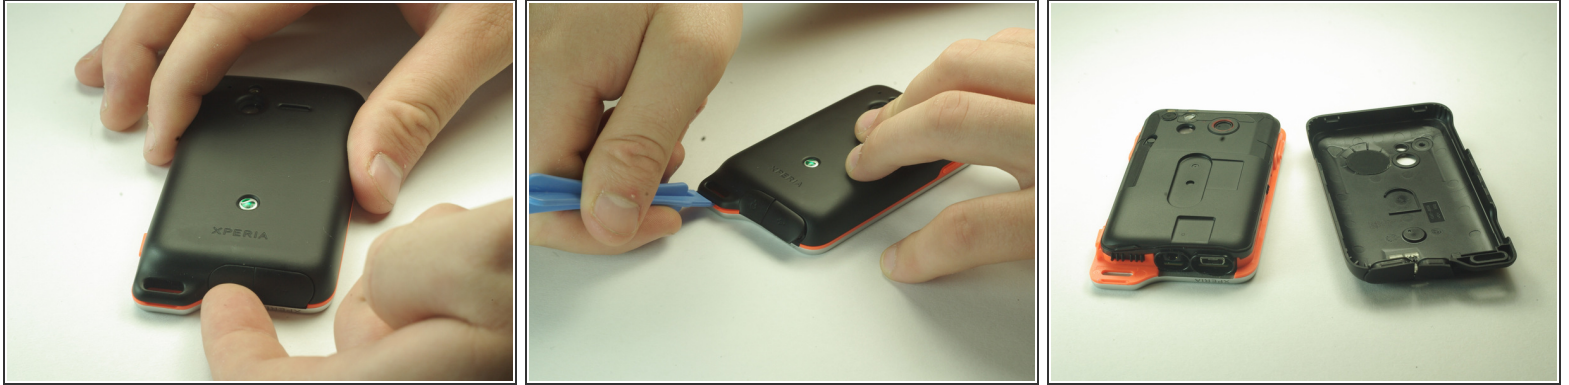
Step 1 — Remove the back cover.

- Open the flaps and remove the back cover using the plastic opening device.

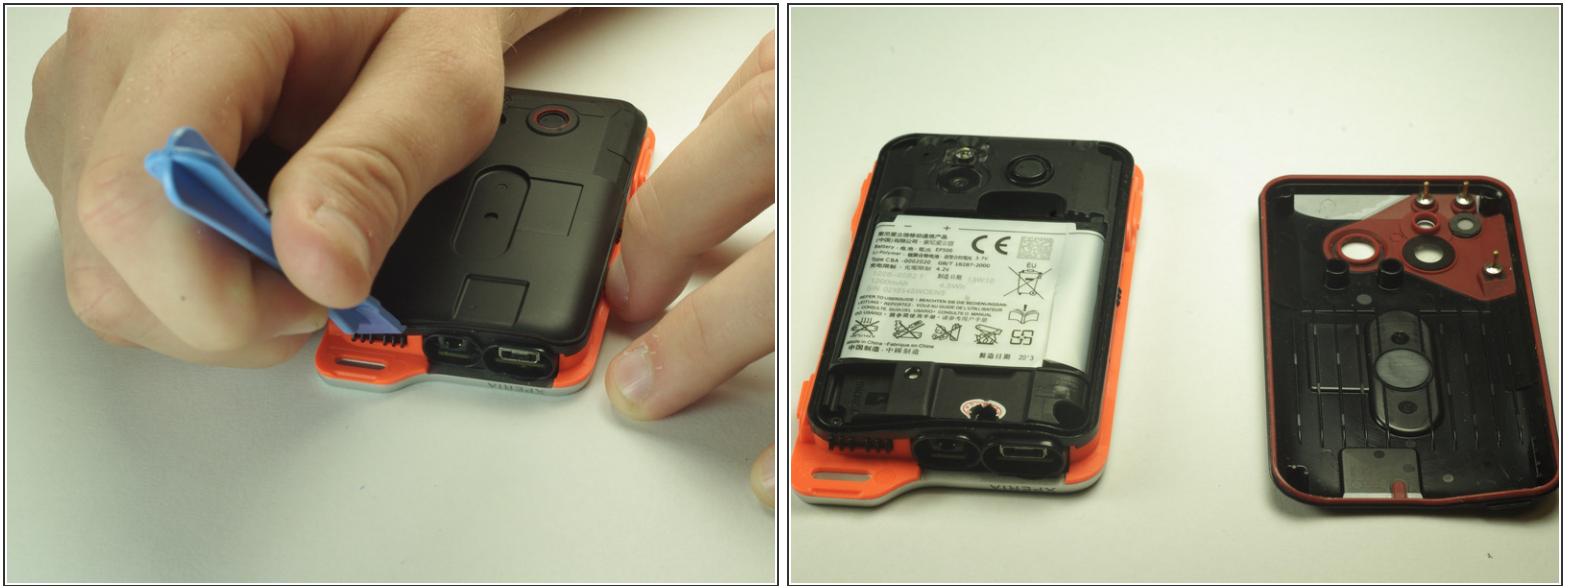
Step 2 — Remove inside plastic battery cover.

- Remove the battery shield with the plastic opening device.

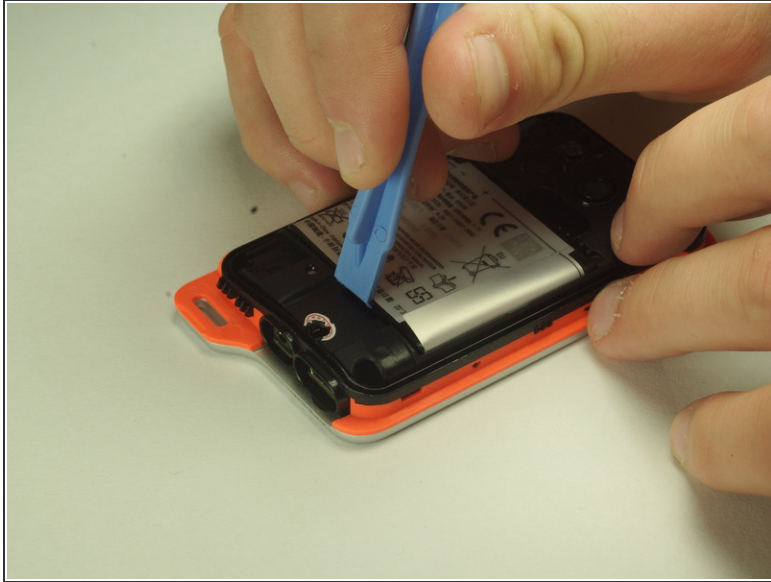
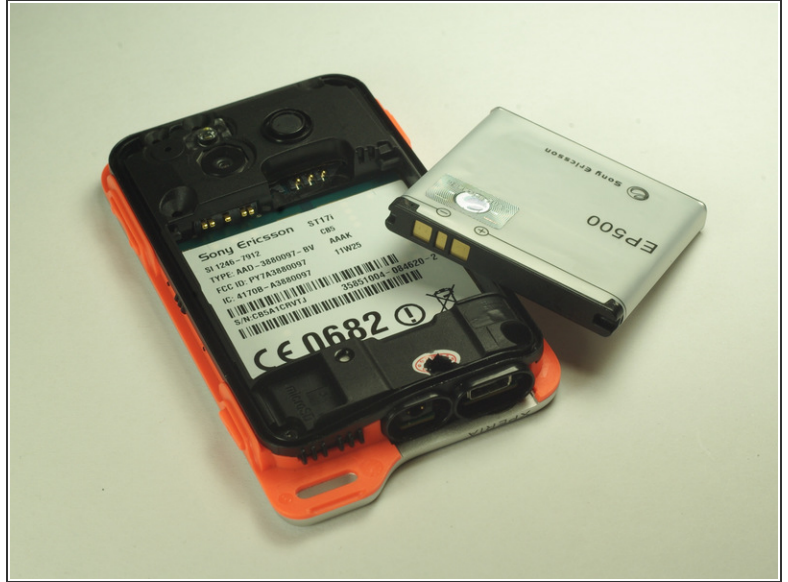
Step 3 — Remove the battery

- Remove the battery.

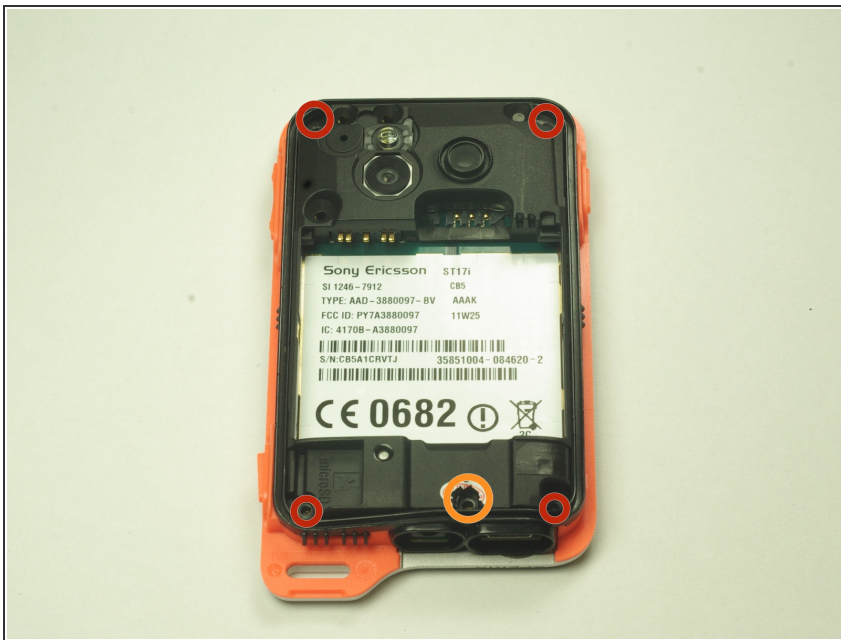
Step 4 — Unfastening The Motherboard Cover

- Unscrew the 5mm screws with the T5 head.
- Unscrew the 6mm screw with the T6 head.

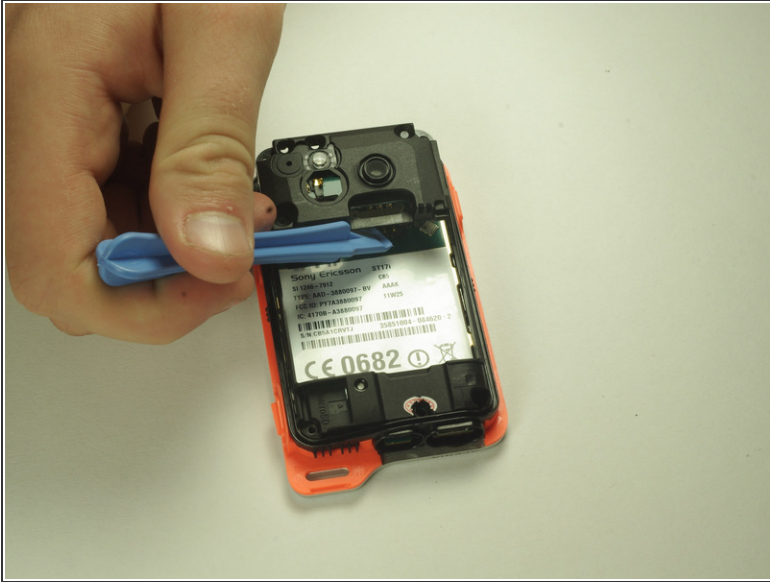
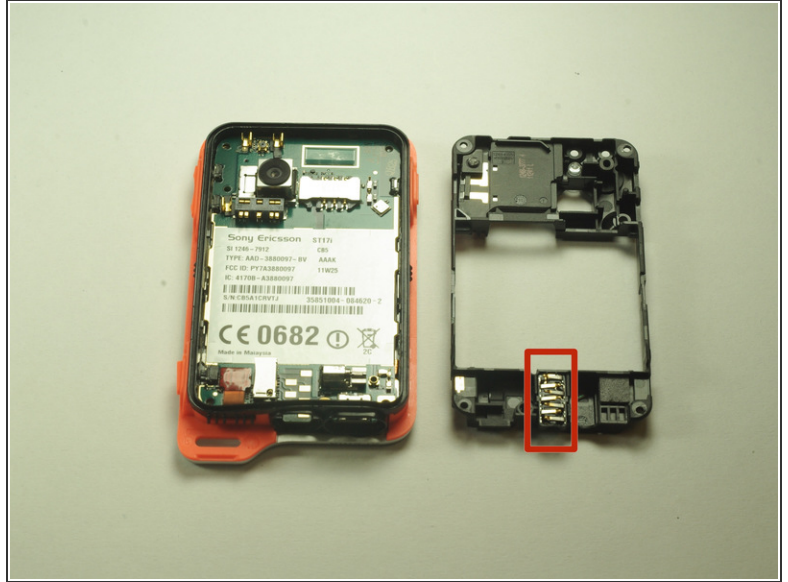
Step 5 — Removing The Motherboard Cover

- Remove the black cover with the plastic opening tool.
- Remove the headphone jack from its slot.
